Returning the tide to East Trinity: an acid sulfate soil remediation case study and lessons for the future

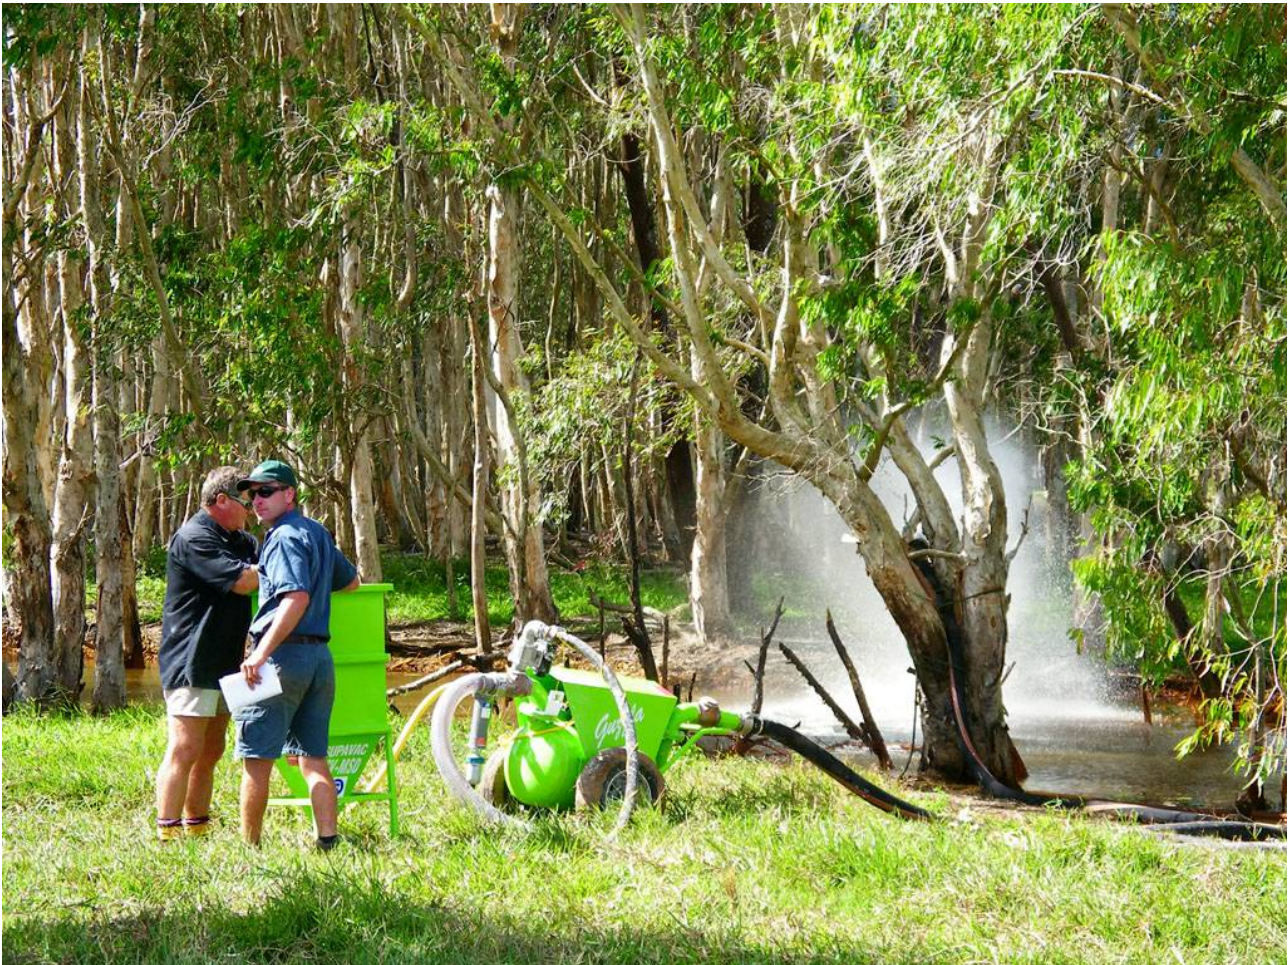
Photo 1

This water treatment machine is light-weight and highly portable making it useful for getting into boggy acidified areas to treat drains that larger equipment cannot get to. This unit also sucks acidified water from the drain and mixes it with hydrated lime $[\text{Ca}(\text{OH})_2]$ before returning the high pH slurry to the drain.

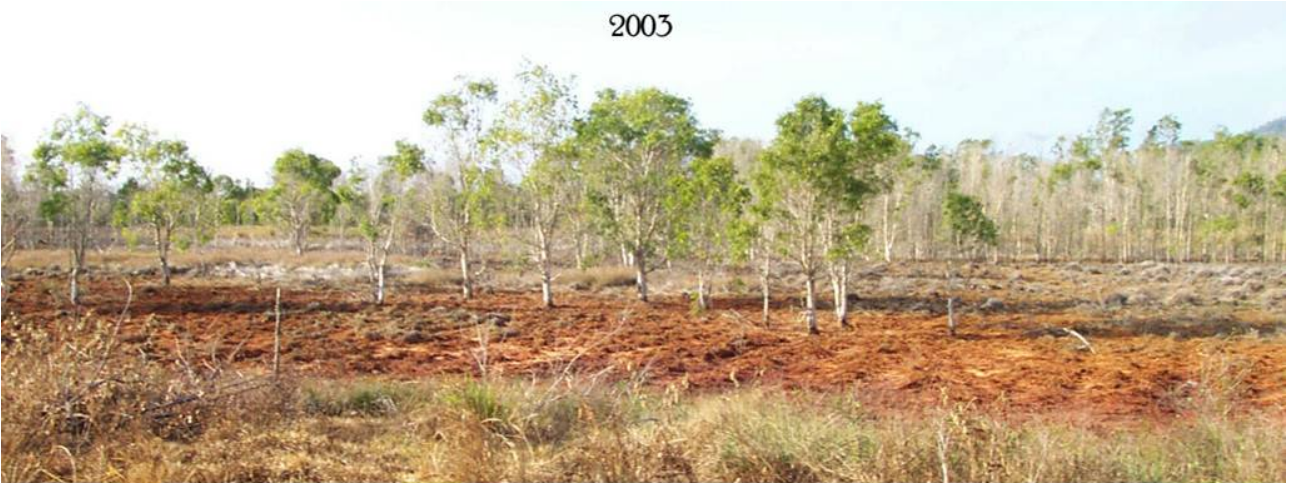
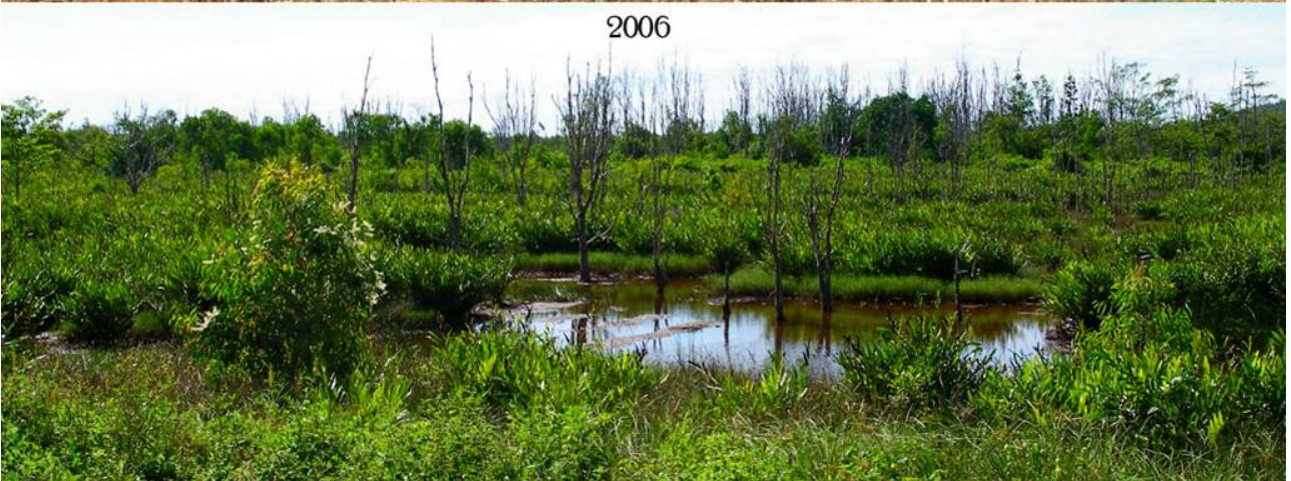
Photo 2

This area receives consistent tidal inundation and the change from the acid-affected terrestrial vegetation (*Melaleucas*, dead grass and iron staining) to marine vegetation (mangrove fern and saltwater couch) is obvious.

Results or outcomes: Our lime-assisted tidal exchange approach has proved very successful in the Hill’s Creek catchment, with water of consistently good quality (e.g. pH >6) leaving the site, colonisation of mangroves and improvements in fish stocks and diversity. Tidal exchange in the Magazine/Firewood Creek catchment has recently begun and is being monitored in a similar fashion.
