# Emergency Coastal Protection Works – Practical Lessons For The Future From The Past

Angus Jackson<sup>1</sup>

<sup>1</sup>Principal Engineer, International Coastal Management

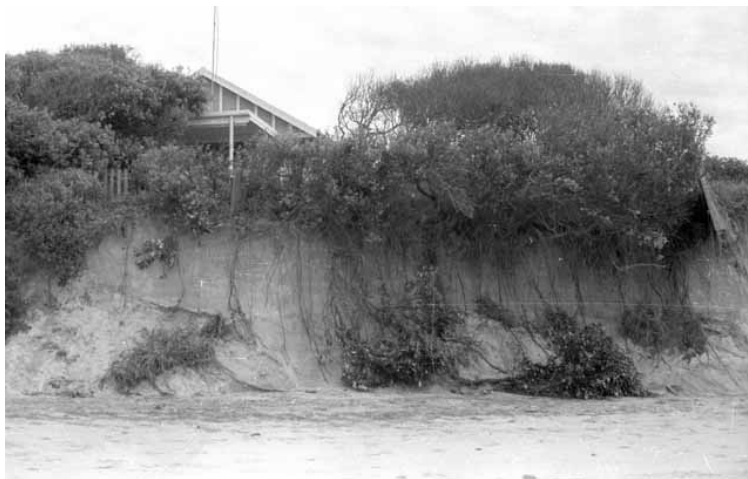
Figure 2 Dune cut

The 1967 cyclones, 7 of them, back to back, caused extensive damage to all of the southern Queensland beaches. In areas with wide well vegetated dunes, the erosion was slowed but eventually the dunes collapsed during the batterings on every high tide (Figure 2).

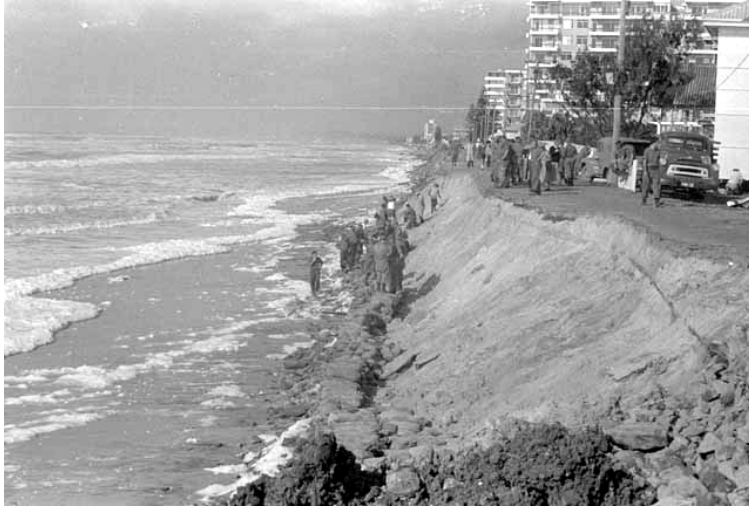
Figure 3 Surfers Paradise Esplanade 1967

It was not just private beach houses and lifesaving clubs that were threatened - the public esplanade roads that had been designed well back from the beach by the early State Government planners were severely damaged. This meant that services such as power and water were cut and access to properties was cut off. Surfers Paradise esplanade is shown in Figure 3.

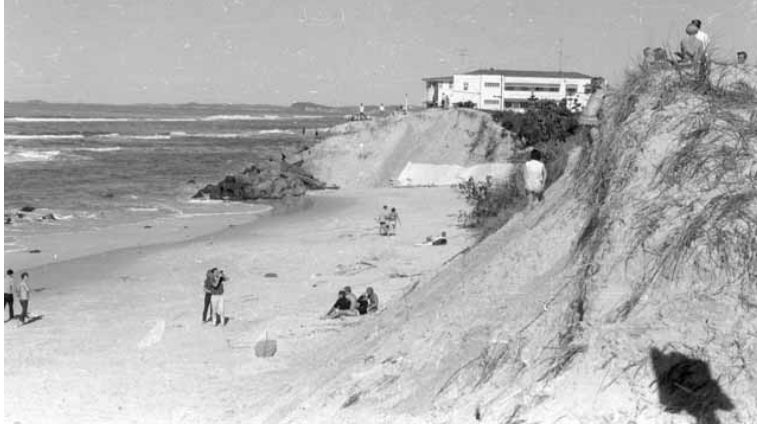
Figure 4 Erosion without protection compared to with adequate protection .

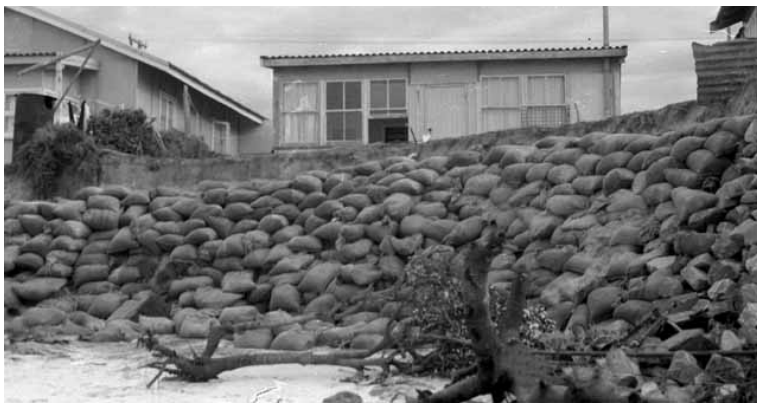
Figure 5 Sand bags

The army were dispatched to deal with the disaster. They brought with them their familiar tool, hessian sandbags (Figure 3 and 5). Larger plastic fertilizer bags were also used by Council and residents but proved less effective due to their low coefficient of friction. Gold Coast City distributed sandbags to owners who filled them using readily available sand, from their yards.

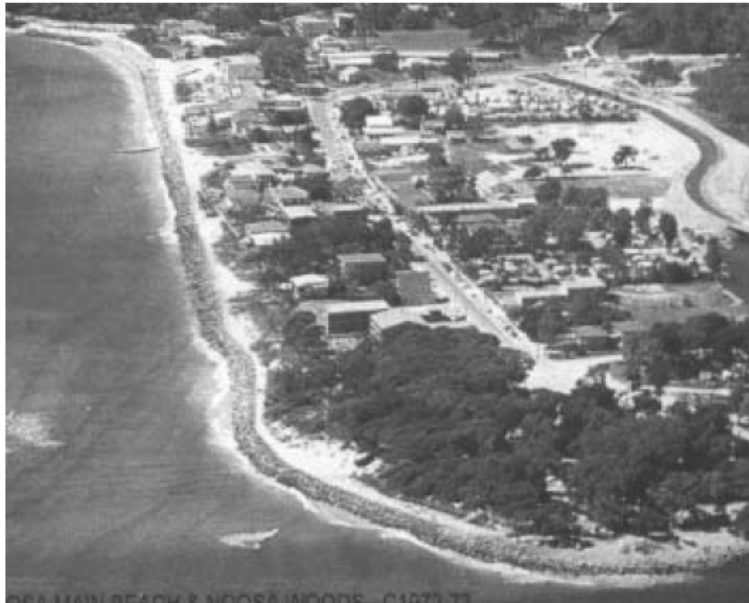
Figure 6 Noosa rock wall 1972-73

Other areas of the Queensland coastline have had similar experiences to the Gold Coast and well constructed emergency walls are common along the Queensland coastline. The emergency rock wall (Figure 6) constructed by Noosa Shire saved Hasting Street while major beach improvement works were designed and implemented. The wall is now buried at the back of the beach where it will limit future severe erosion events, when they next happen.

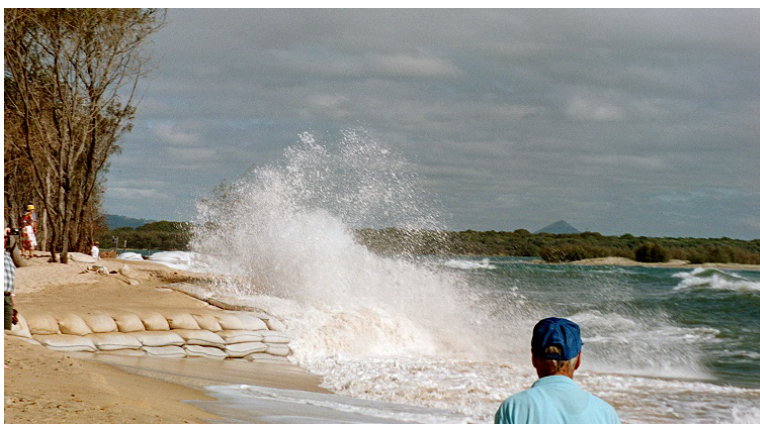
Figure 7 Maroochy sand bag wall

Sand is a readily available material along the coast and the use of sand bags has also evolved. In recent times, Maroochy Shire used modern “sand bags” to protect their caravan park (Figure 7). This allows the works to be done quickly and easily removed after the event, if required.
