The shifting sands of jurisdictional responsibility in coastal management

ABSTRACT

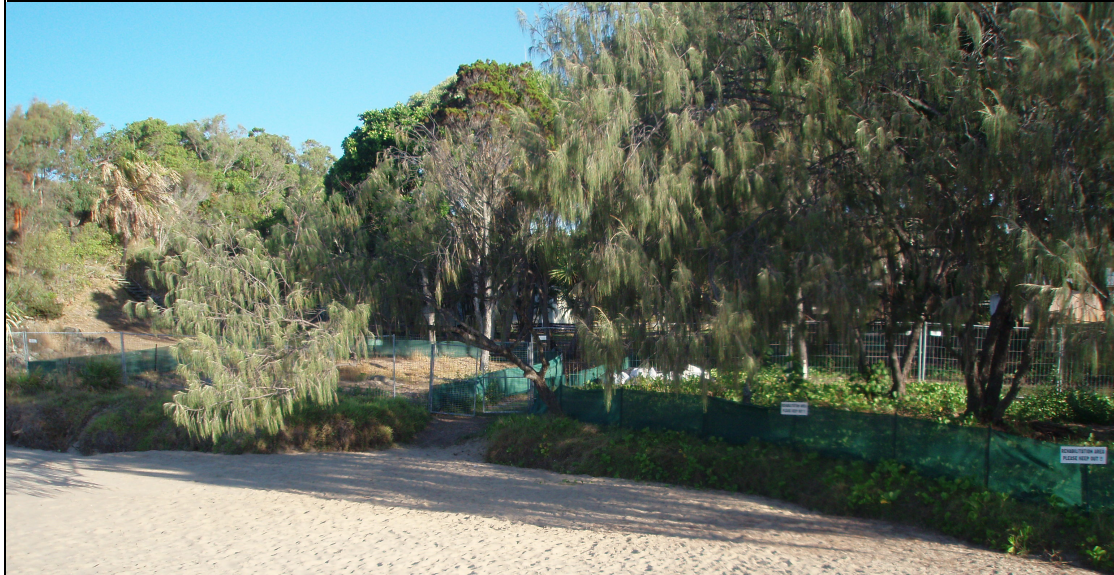
Figure 2. Revegetation area.

As the clearing works scraped the surface of the ground, the previous plant's roots (mainly goat's foot convolvulus (*Ipomoea pes-caprae*) and coastal vitex) assisted in rapid natural regeneration in some areas. However, as a result of the enforcement notice, the disturbed area was fenced, weeding undertaken, and supplementary plantings of native species completed (refer to Figure 2). As with most revegetation programs on coastal dunes, it is important that regular weeding is undertaken until the ground cover has substantially re-established.

To ensure that the damage to the dune was remediated, a coastal protection notice under the *Coastal Protection and Management Act 1995* (Coastal Act) was issued. This notice directed action to be taken to protect the disturbed frontal dune which included restricting access to the land, planting, cultivating and preserving vegetation native to the area, and to do anything else necessary to protect the land from wind erosion.

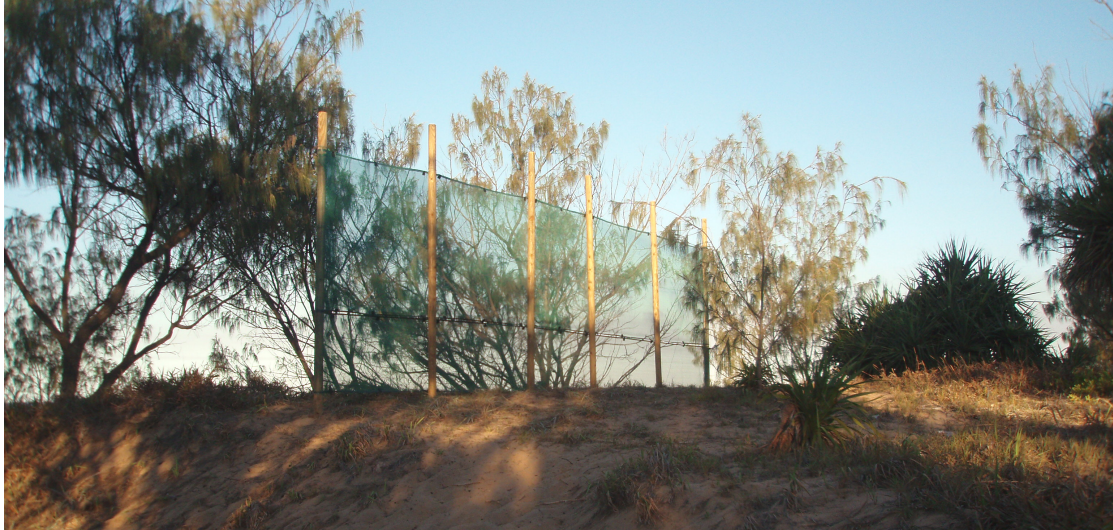
Figure 3. Wind screen.

To assist with revegetation of the cleared and damaged areas, Council, the Burnett Mary Regional Group (BMRG) and landcare group, revegetated certain areas, installed signage, and installed three 10m long by 3m high screens to mimic the natural wind resistance given by the previous vegetation (refer to Figure 3). These screens also restricted the view corridors to the coast of adjacent new development.

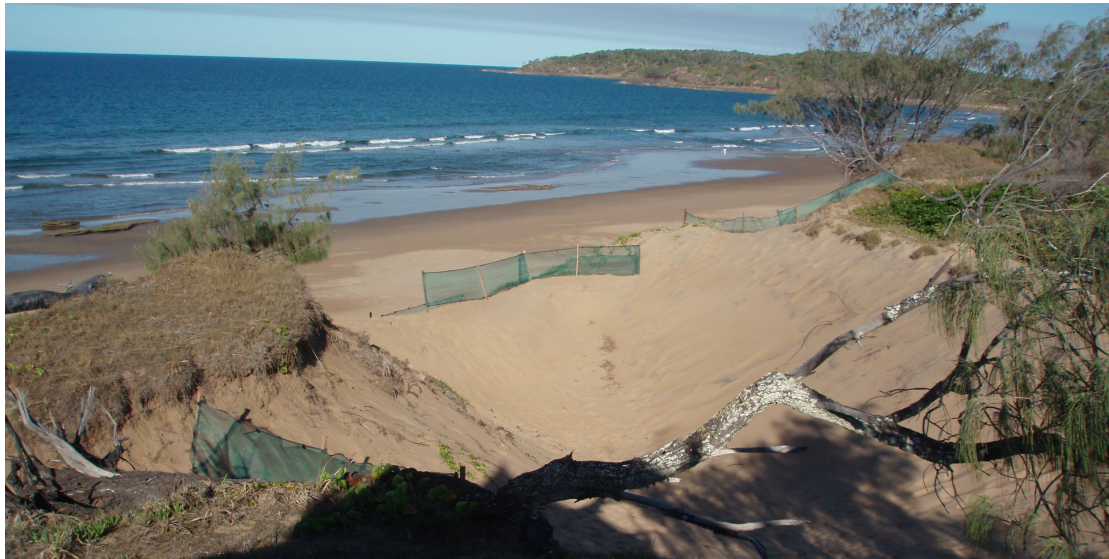
Figure 5. Sand blow area.

Uncontrolled access to the beach had resulted in two tracks to the beach being created one to the north and one through the sand blow to the south. Since the initial subdivision the sand blow had increased in area and the frontal dune was lowered to the level of the beach.

To resolve the situation, Miriam Vale Shire Council obtained additional funding through the BMRG to assist in completing rehabilitation works. Rectification works were completed using the bond and the additional funding from BMRG. This included removal of rock material, and construction a new access to the beach. The track through the sand blow area was closed and an excavator used to re-establish the natural height of the frontal dune. This has assisted to accelerate the natural dune rebuilding process, and reduced loss of sand to wind erosion. Stabilisation of the

frontal dune with plants and wind break screens followed quickly to ensure the stability of this area.
